TFD 72-1220

EMP TEST PLAN FOR EVALUATING THE SHIELDING  
EFFECTIVENESS OF THE B-1 AVIONICS BAY ACCESS  
DOOR UTILIZING A SLANT COIL SPRING AS THE EMP SHIELD

19 October 1972

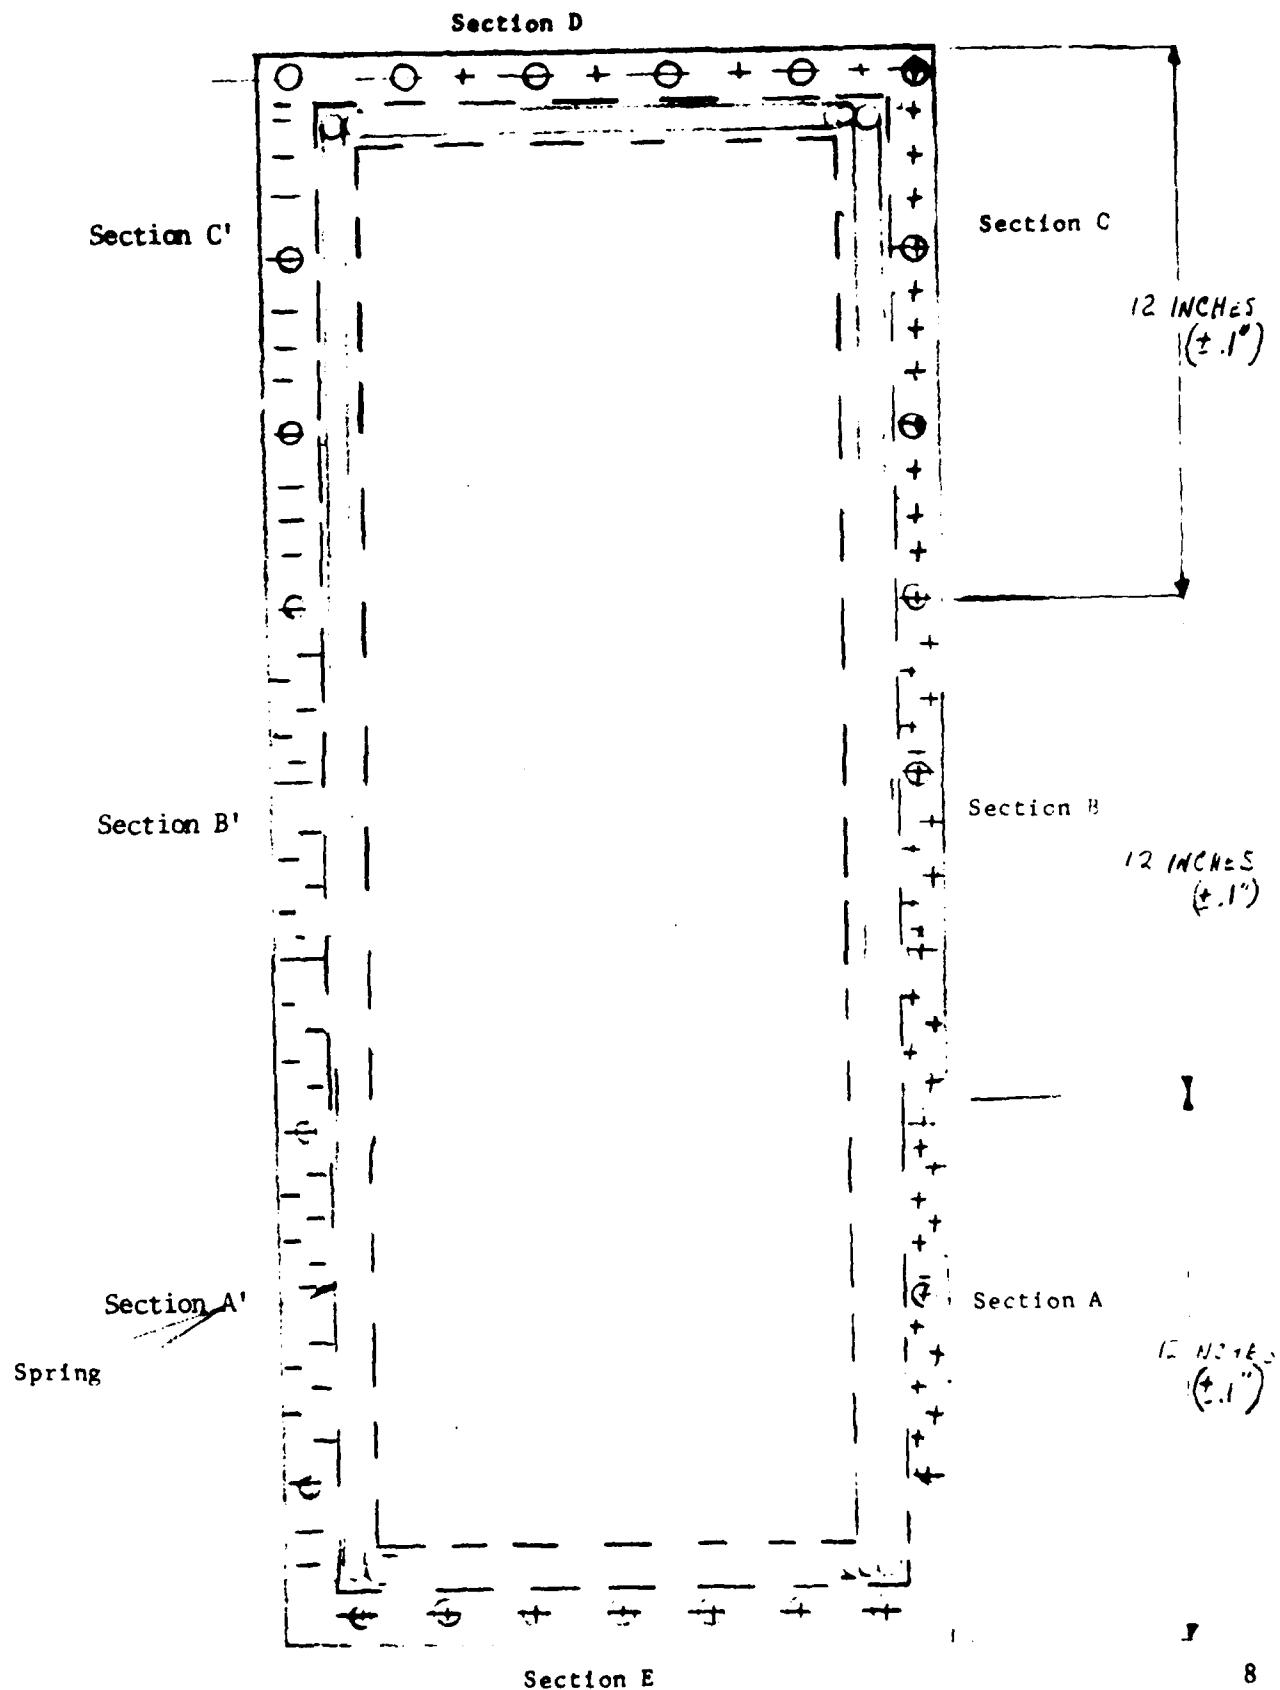
Figure 1

Test Configuration

Tests shall be accomplished with the test panel place. Install access door with tridair fastners tightened down secure. fixture transmission lines will be mounted in section A. Reference figures 1, 2 and 3.

3.1.1 Perform shielding effectiveness (SE) measurements at continuous wave frequencies of 10 KHz, 100 KHz, 1 MHz, 10 MHz and 100 MHz with test fixtures installed in section A. Reference figures 1, 2 and 3. Take pictures with oscilloscope camera of scope trace at all frequencies. Record measurements. Properly identify all pictures.

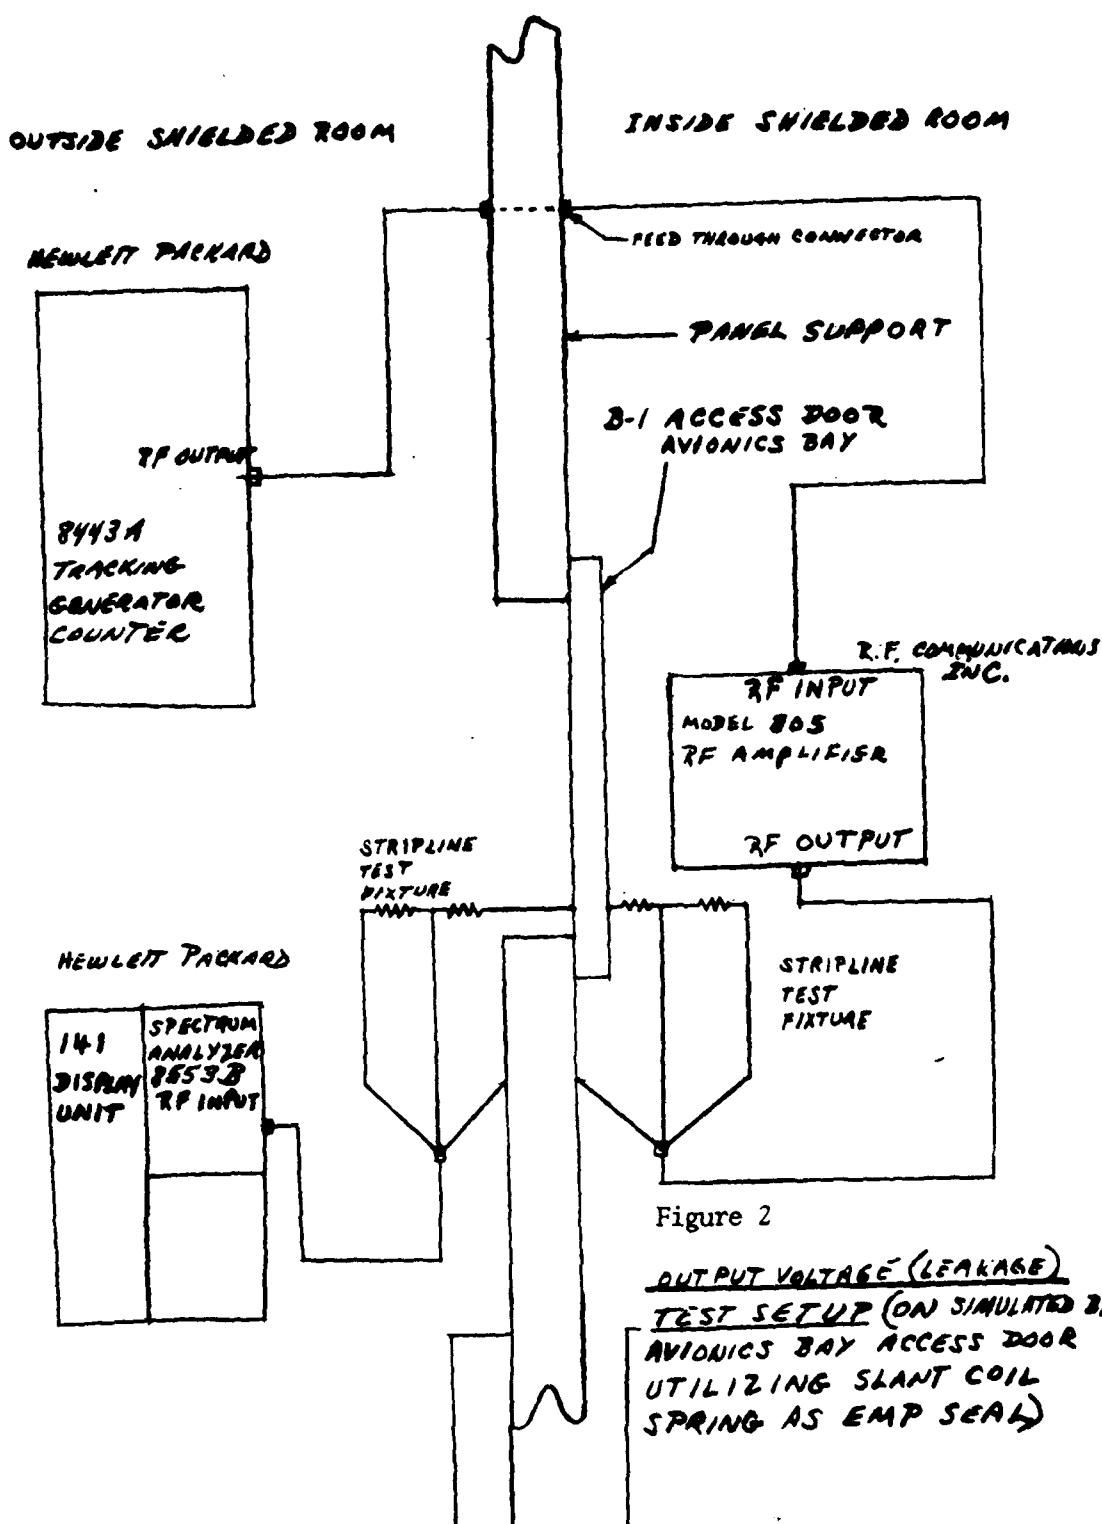
Figure No.	Title	Page
1	Test Configuration . . . . .	8
2	Shielding Effectiveness Test Setup on Simulated B-1 Avionics Bay Access Door Utilizing Slant Soil Spring As EMP Seal . . . . .	9
3	Stripline Test Setup . . . . .	10
